10 March 2012

Mr. Charlie Cobb
Alaska Department of Natural Resources
State Dam Safety Engineer
Division of Mining, Land and Water

At 6:00 PM last night (9 March 2012) we noticed a pool of water formed on the road beneath the tailings storage facility. On inspection of the dam crest, it was observed that the dam was overtopping. The flow was just initiated, because several people had been active in the area prior on the same day, including me, and nothing was noticed.

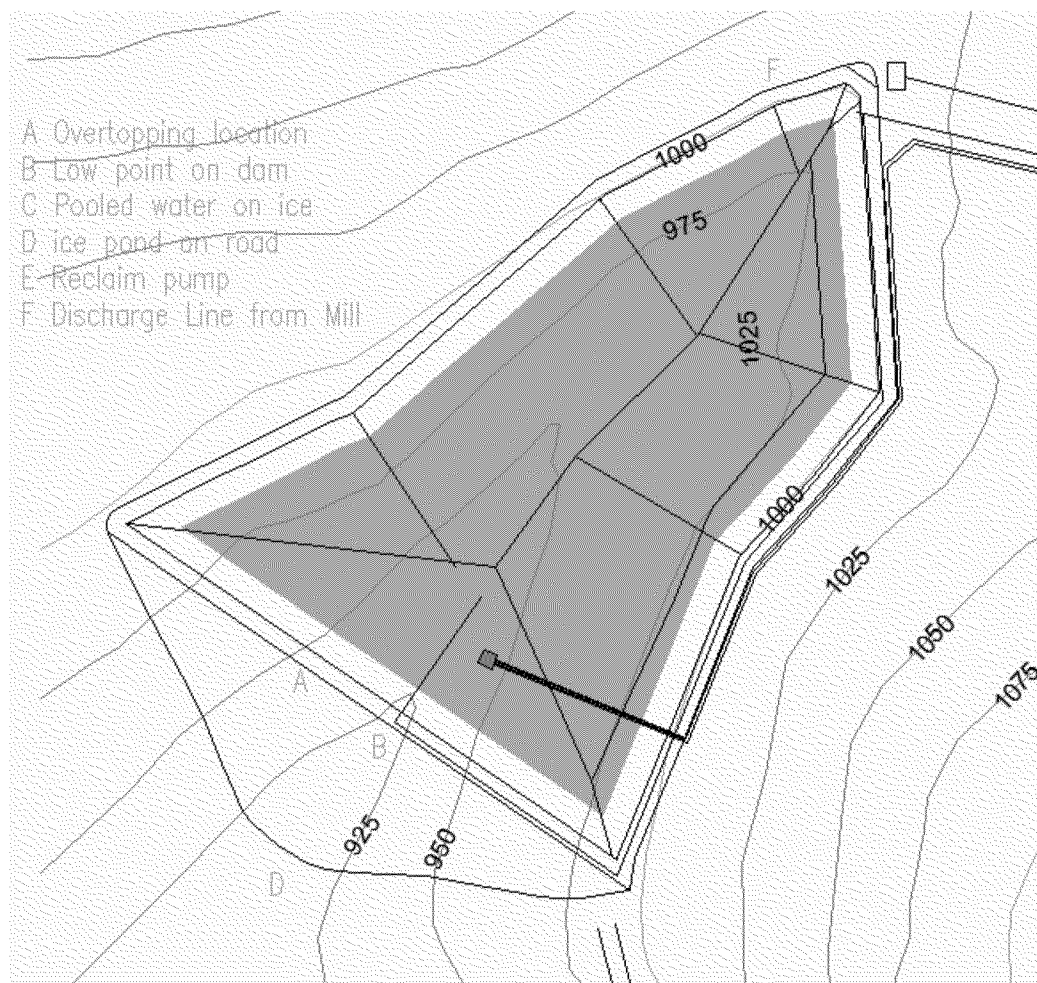
Figure 1: Overtopping Situation at the TSF

The overtopping site (A) is not the low point of the dam; the “Vee” notch area that slumped 18 inches due to permafrost melting (B). It is estimated to be 45 ft northwest of the low point. There is also evidence pooling on the western corner of the dam (C) and a pool of water collected at the low point in the valley access road (D).

We have not added any fill to the TSF since we were issued with the non-compliance order by the BLM on 13 Jan 2012, and have only recirculated water to and from the mill. Water is sent to the mill from beneath the ice near the dam at the reclaim barge (E) and returns to the pond on the upstream side (F).

The ice appears to have rotated and been pushed over the dam crest. The water is flowing from beneath the ice, between it and the dam liner. It is unclear why the water is overtopping at the location it is rather than the low point of the dam.

1. To stem the flow, we have reduced circulation of water to and from the mill. We have not stopped adding the recirculation water to the pond, as stopping the flow in both lines will make them both freeze.
2. We will begin hauling water in our 2500 gallon vacuum truck to the FTDS collection pond for temporary storage and will continue to do so until the flow is stopped.
3. We are surveying the elevation of the breach, the low point in the dam, and the low point on the ice level adjacent to the reclaim barge.
4. We will collect the frozen water on the access road and return it to the pond.

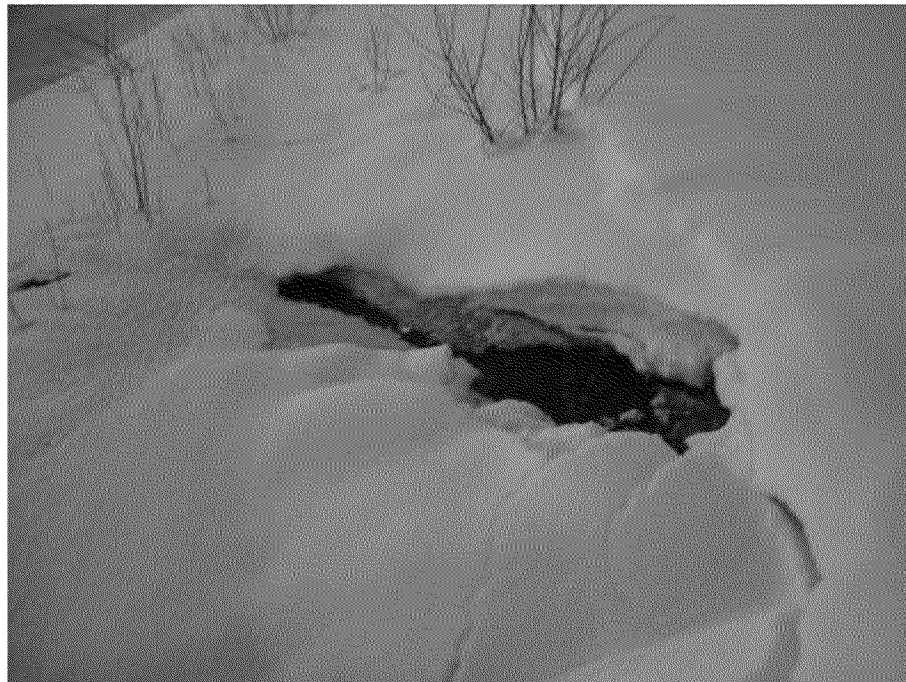
Figure 2: Site A - Water Overtopping Dam (Mar 9, 7 PM)

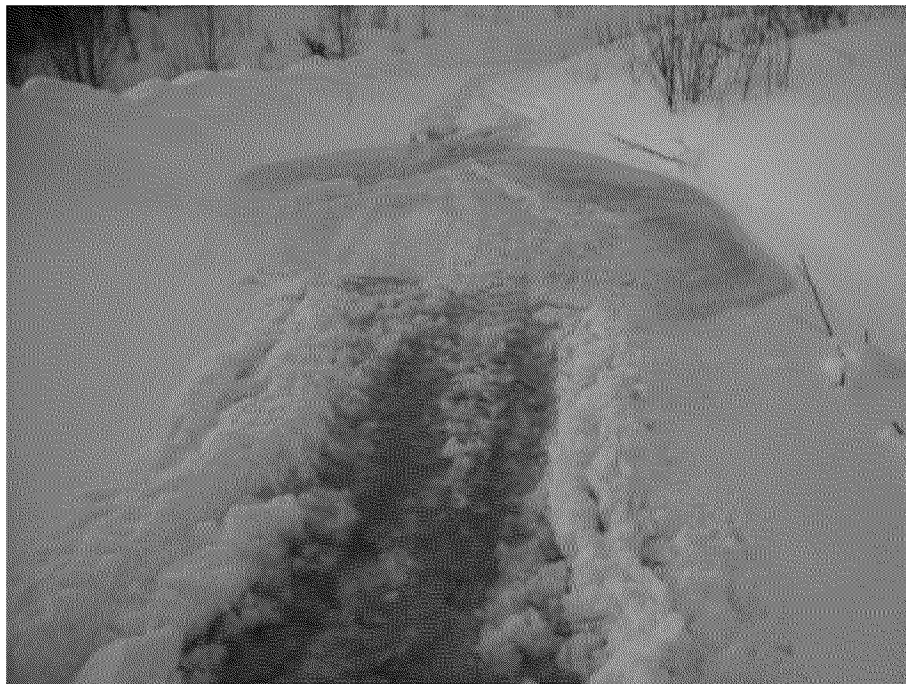
Figure 3: Site D - Water Pond on Access Road (Mar 9, 7PM)

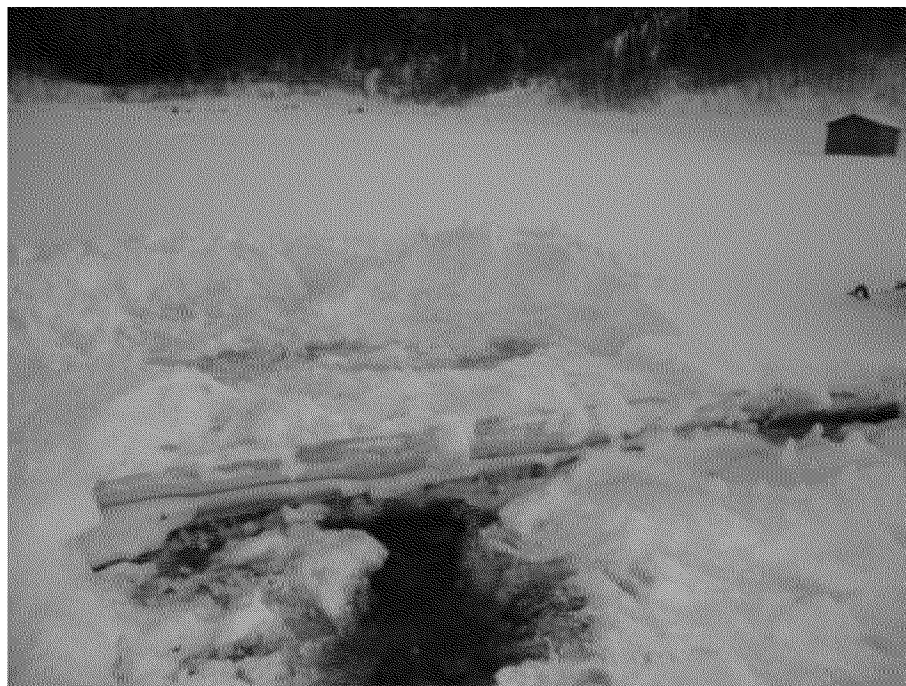
Figure 4: Site A - Water Overtopping Dam (Mar 10, 11 AM)
Note water flowing between ice and liner.

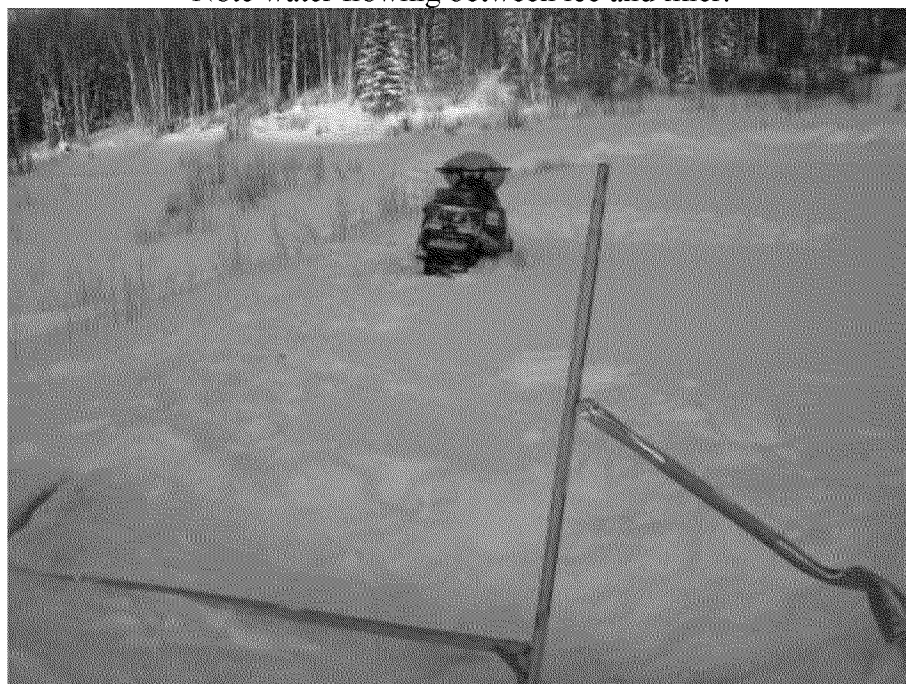
Figure 5: Site B – The Gauge at the Low Point in the Dam, looking towards Site B past Snow Machine

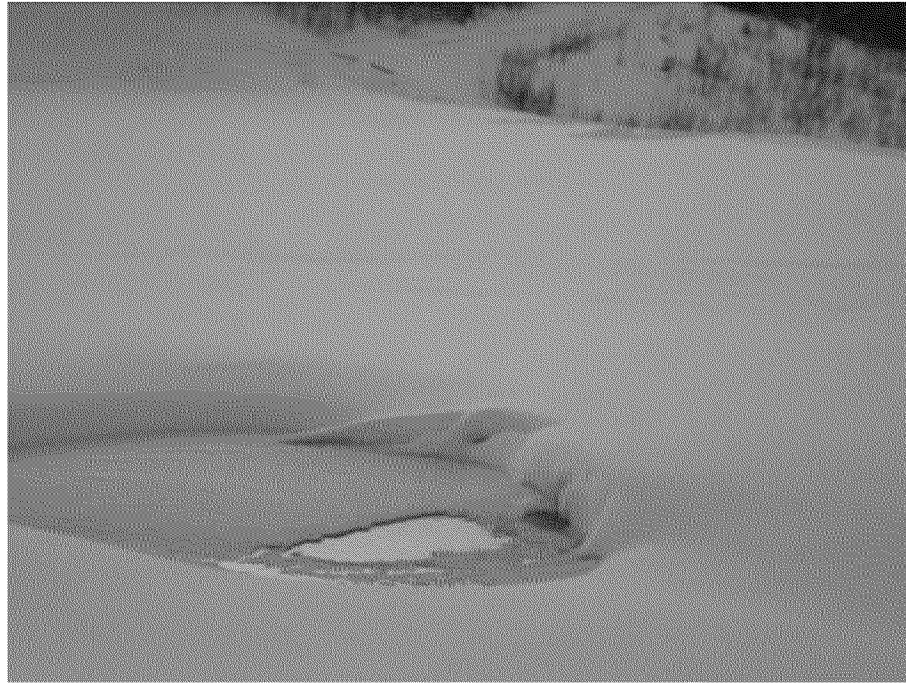
Figure 6: Site C - Pond on the Western End of Dam
